Unexpected intravascular retention of coil device

Sang-Jeong Song, M.D., Sang-Jun Suh, M.D.

Department of Neurosurgery, Daegu Fatima Hospital, Daegu, Korea

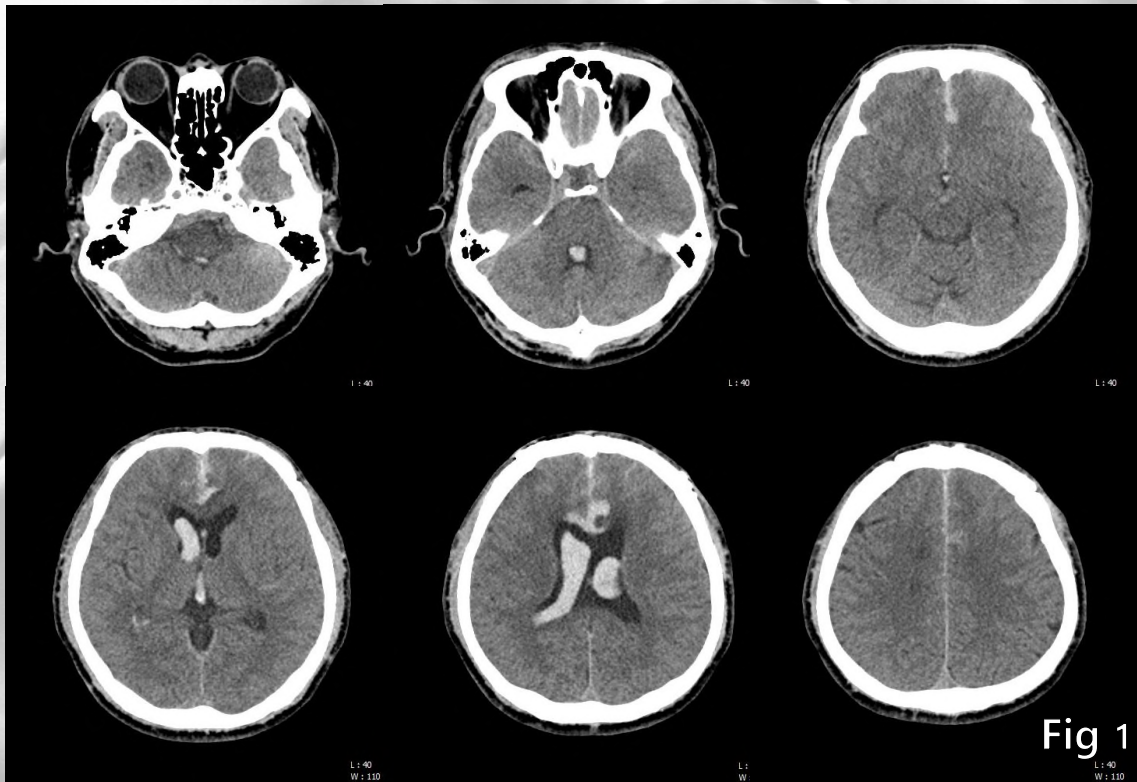
Fig 1

A 59-year-old man visited the hospital with severe headache. Brain Computed tomography(CT) showed subarachnoid hemorrhage(Fig 1). In cerebral angiography, left distal anterior cerebral artery (ACA) aneurysm was confirmed(Fig 2).

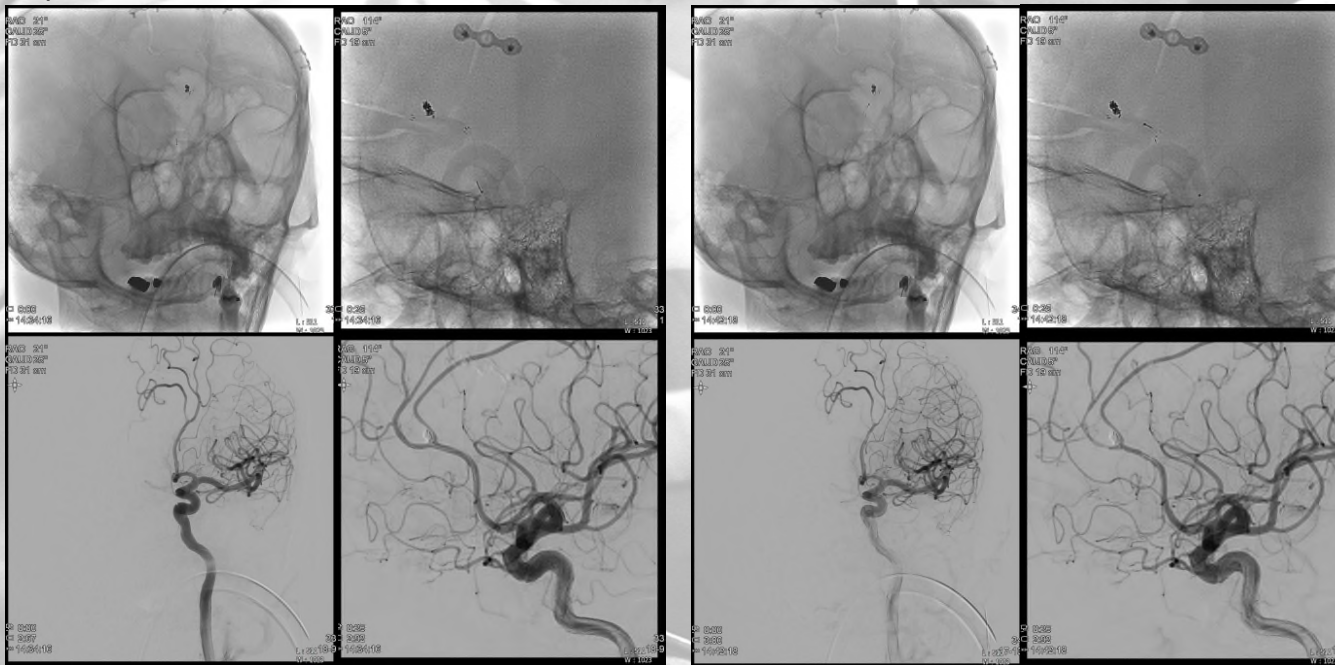
Fig 3

Coil embolization was performed using axium coil (EV3, medtronic) and stent (Neuroform Atlas, stryker)(fig. 3). There was no specific problem during procedure, but kickback of the microcatheter tip toward the parent artery was observed after the detachment of the last coil, pulling was impossible to remove coil wire(fig. 4). When pulling force was applied, the stent came out together proximal, and it was confirmed that the marker of the coil wire was pushed up to distal direction beyond the stent(fig. 5).

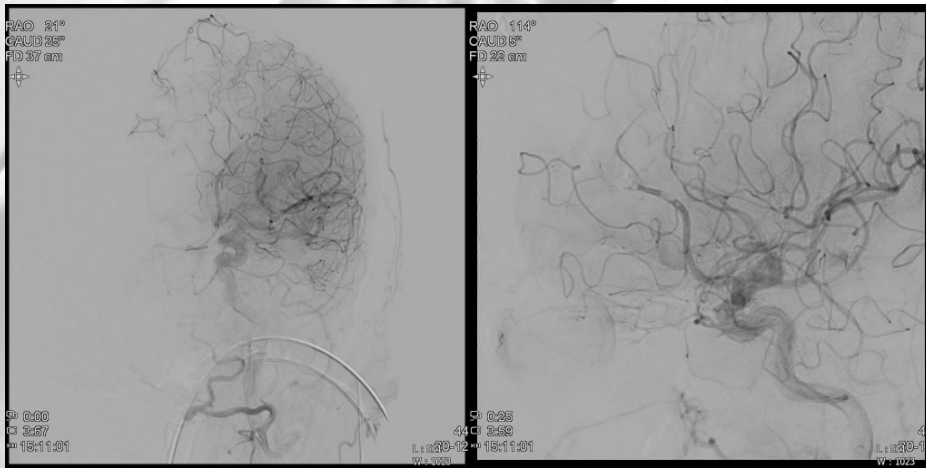
Fig 6

It was judged to situation in which a part of the coil was stretched without coil detachment and was caught between the stent with coil wire. So external torque force was applied to remove even a part of the coil wire. After that, the coil wire could be pulled out, but only part of coil wire was removed. The marker of the coil wire still remained in the distal ACA and remained stuck between the stents along with the coil stretching part, and the distal ACA flow was weakened by thrombus formation(Fig. 6), so a longer size stent was added from the proximal area than the residual material observed on angiography(fig. 7).

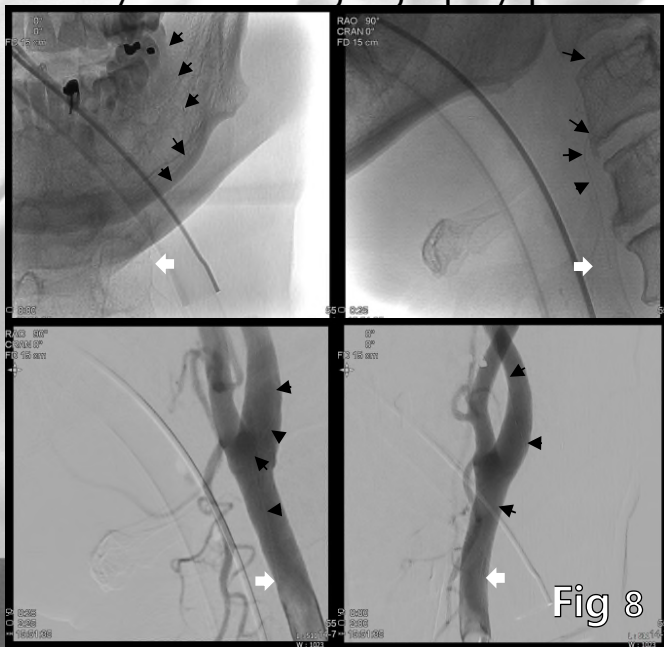
Fig 8

The remaining coil wire was confirmed from the distal ACA to the lower part of the carotid bulb through the internal carotid artery, and it was determined that prevention of thromboembolic event due to unstable movement was necessary (Fig. 8). After performing an additional stent (PROTEGE RX, medtronic) of the internal–common carotid artery for sufficient residual wire covering, there was no movement of the remaining coil wire, and arterial flow was well observed on last angiography (Fig. 9). The patient recovered without any neurologic deficit, and there was no thrombus in intracranial artery in the angiography performed the next day (Fig. 10).

white arrow = tip of coil wire
black arrow = coil wire
